Thermographic Survey Report

ABC Manufacturing

Zarheer Jooma PE IEEE (SM)

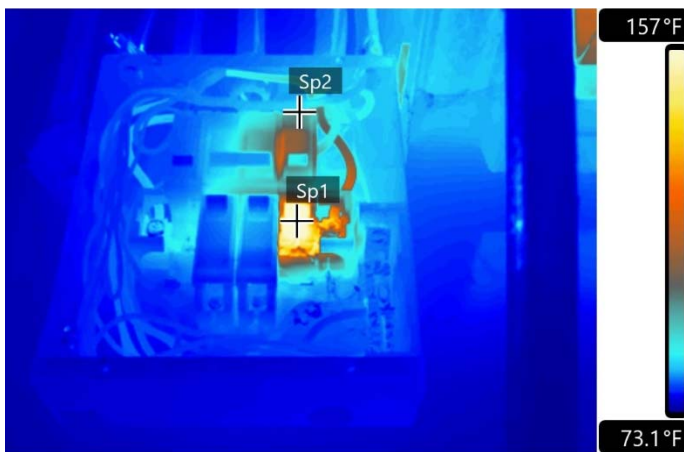
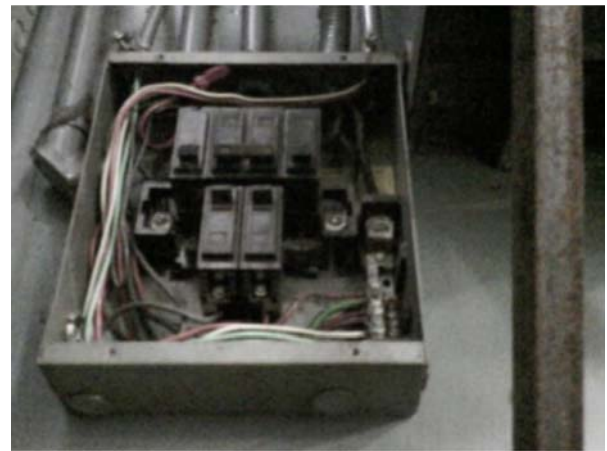
OWNER	NOMENCLATURE
	LOCATION: Shipping/West Wall/South EQUIPMENT ID: Panel LV3/Fan Men's Room TARGET: Breaker 8 CONDITION: Serious

Dt1 (Sp1 - Sp2)	70.1 °F
Sp1	160.0 °F
Sp2	89.9 °F
Areas	-
Ellipses	-

PROBLEM	Bus connection
CORRECTIVE ACTION TAKEN	
RECOMMENDATION	Replace breaker
REMARKS

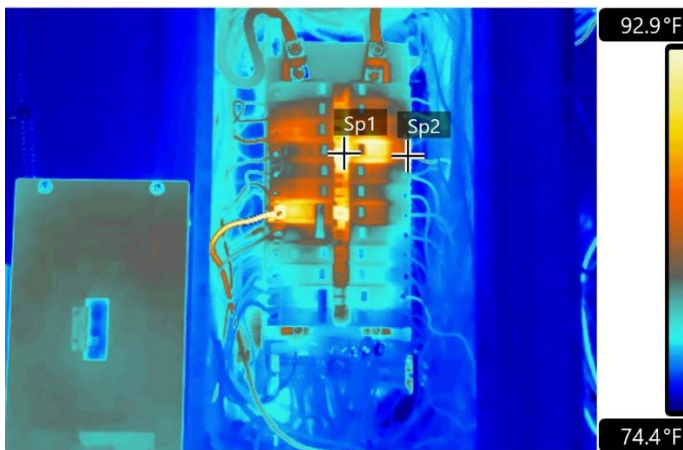
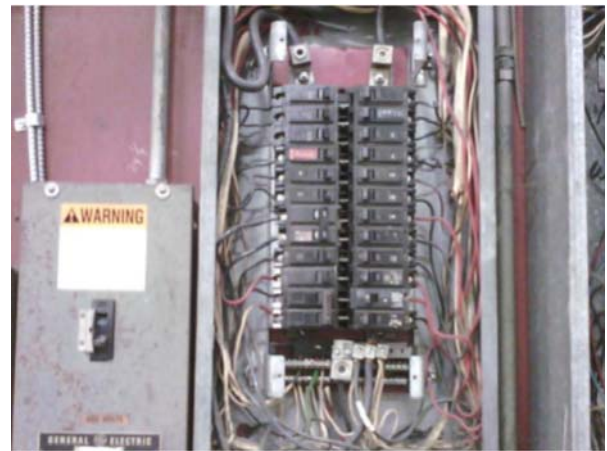
OWNER	NOMENCLATURE
	LOCATION: West Wall/Office Entry EQUIPMENT ID: Panel BPOP1/Unnamed Breaker 8 TARGET: Bus connection CONDITION: Serious

Dt1 (Sp1 - Sp2)	21.6 °F
Sp1	103.5 °F
Sp2	81.8 °F
Areas	-
Ellipses	-

PROBLEM	Breaker
CORRECTIVE ACTION TAKEN	
RECOMMENDATION	Replace breaker
REMARKS

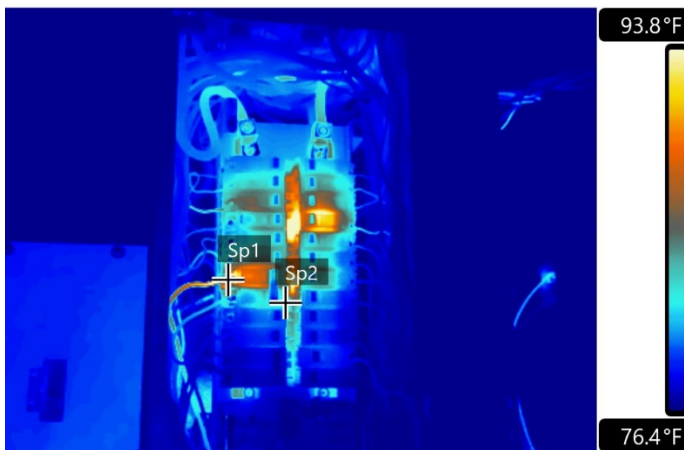
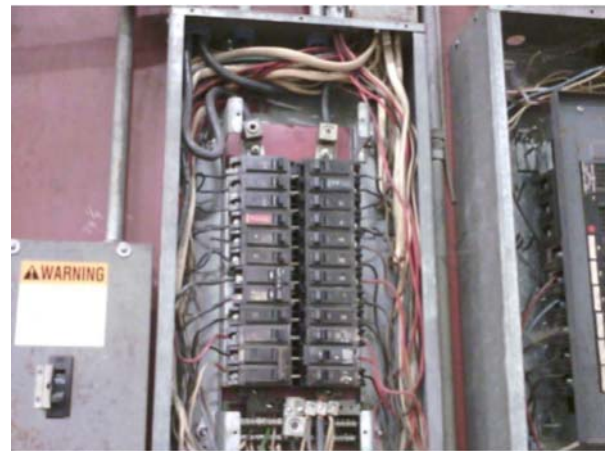
OWNER	NOMENCLATURE
	LOCATION: Ship/West Wall/Office Entry EQUIPMENT ID: Panel PBP1/Unnamed Breaker 13,15 TARGET: Circuit 13 CONDITION: Intermediate

Dt1 (Sp1 - Sp2)	15.9 °F
Sp1	97.9 °F
Sp2	82.0 °F
Areas	-
Ellipses	-

PROBLEM	Loose wire connection
CORRECTIVE ACTION TAKEN	
RECOMMENDATION	Screw was tightened
REMARKS

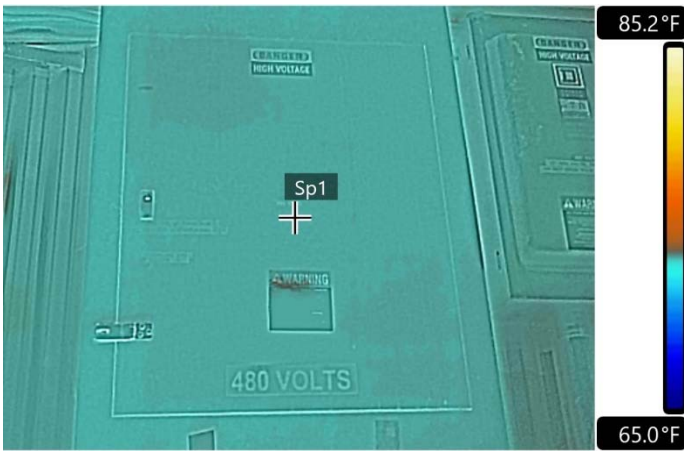
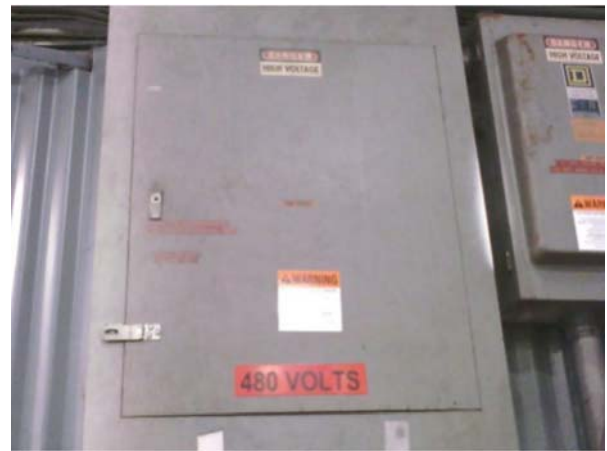
OWNER	NOMENCLATURE
	LOCATION: Ship/West Wall/Office Entry EQUIPMENT ID: Panel HVP/Ship/1 TARGET: Feeder conduit CONDITION: Intermediate

TECHNICIANS SUMMARY	
PROBLEM	Hole around conduit
CORRECTIVE ACTION TAKEN	
RECOMMENDATION	Cover hole
REMARKS	NEC violation. Also any item installed with a disconnect handle exceeding a height of 6'7" from floor in the "On" position is in NEC violation.

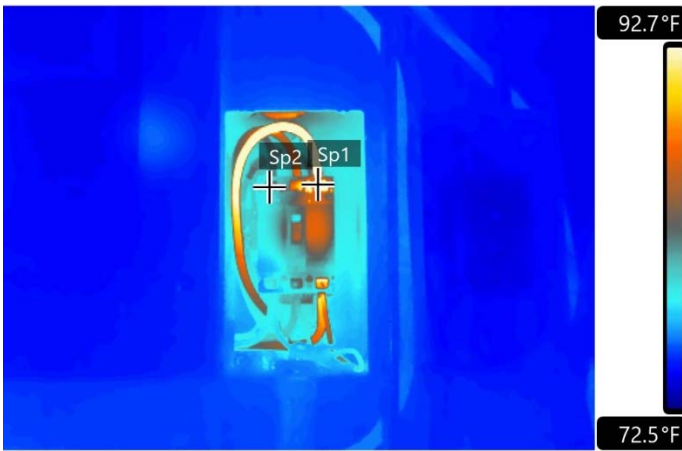
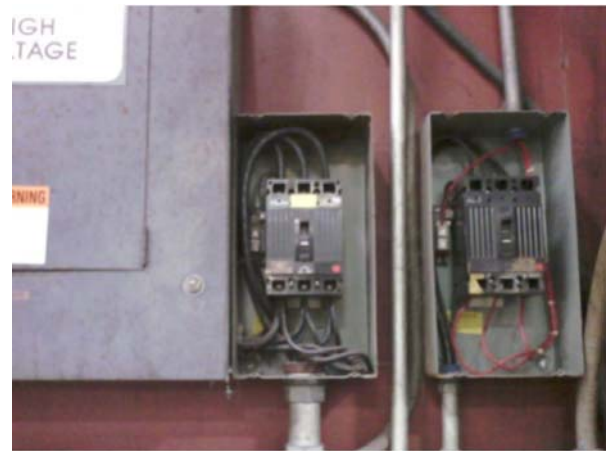
OWNER	NOMENCLATURE
	LOCATION: Ship/West Wall/Office Entry EQUIPMENT ID: Breaker HVP/Ship/1 TARGET: C-Phase line side wire connection CONDITION: Serious

THERMAL READINGS	
Dt1 (Sp1 - Sp2)	23.4 °F
Sp1	105.8 °F
Sp2	82.4 °F
Areas	-
Ellipses	-

TECHNICIANS SUMMARY	
PROBLEM	Loose wire connection
CORRECTIVE ACTION TAKEN	
RECOMMENDATION	Check all connections
REMARKS

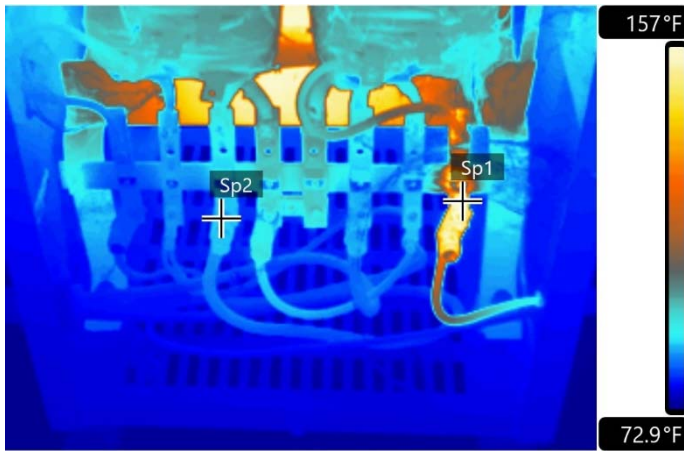
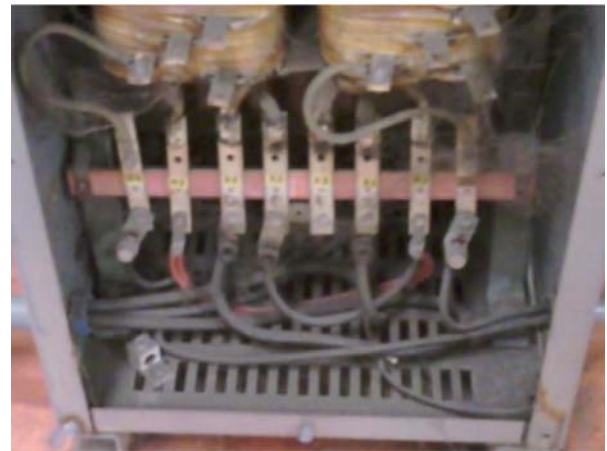
OWNER	NOMENCLATURE
	LOCATION: Ship/West Wall/Office Entry EQUIPMENT ID: T-BPOP1 TARGET: High voltage right wire lug CONDITION: Serious

Dt1 (Sp1 - Sp2)	71.5 °F
Sp1	162.5 °F
Sp2	91.0 °F
Areas	-
Ellipses	-

PROBLEM	Loose lug connection
CORRECTIVE ACTION TAKEN	
RECOMMENDATION	Check all connections
REMARKS	Transformer is not properly grounded to XO lug and building steel as per the NEC

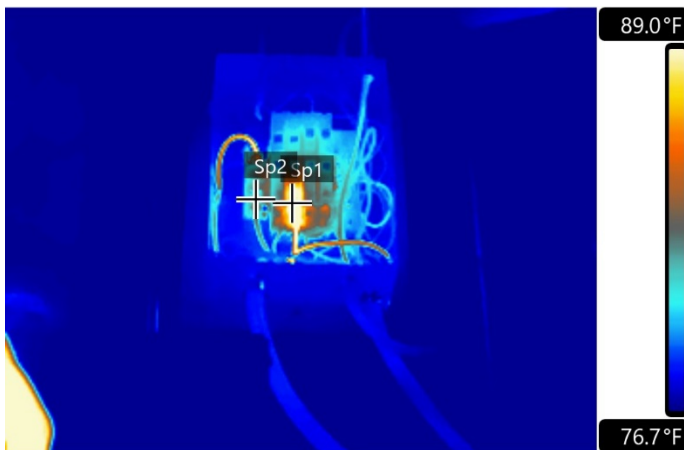
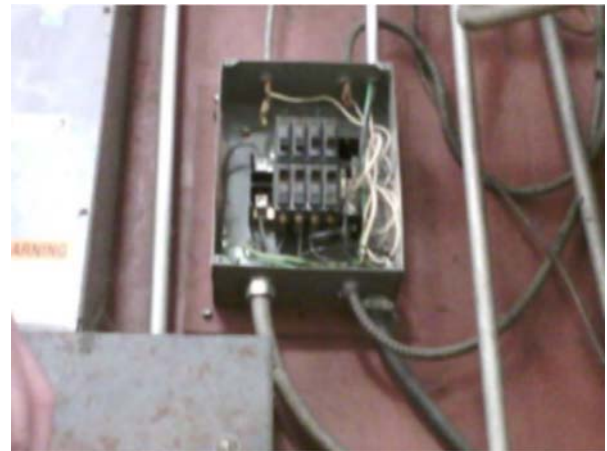
OWNER	NOMENCLATURE
	LOCATION: Ship/West Wall/Office Entry EQUIPMENT ID: Panel LV1/N. End Plugs TARGET: Breaker 6 CONDITION: Intermediate

Dt1 (Sp1 - Sp2)	13.8 °F
Sp1	94.6 °F
Sp2	80.8 °F
Areas	-
Ellipses	-

PROBLEM	Loose wire connection
CORRECTIVE ACTION TAKEN	
RECOMMENDATION	Screw was tightened
REMARKS

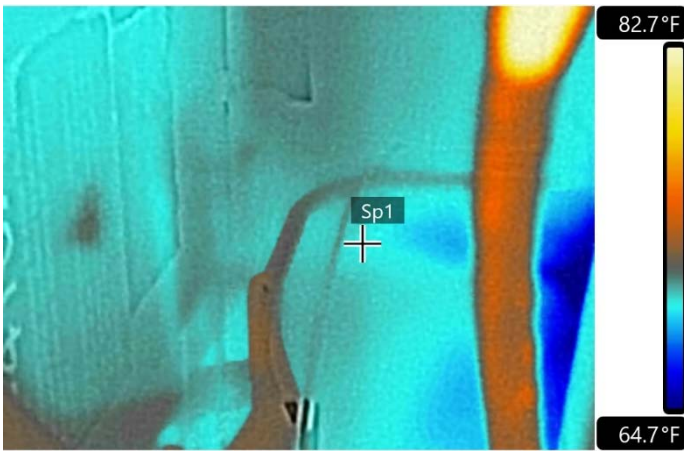
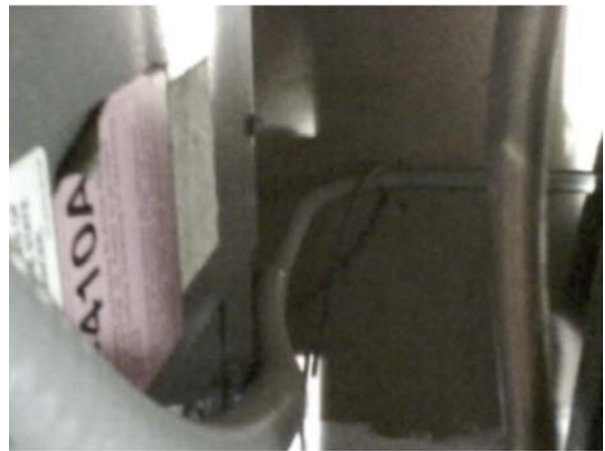
OWNER	NOMENCLATURE
	LOCATION: Mechanical Room/2nd Floor EQUIPMENT ID: AHU-2 TARGET: Conduit with feeder wiring CONDITION: Serious

TECHNICIANS SUMMARY	
PROBLEM	Improper conduit run.
CORRECTIVE ACTION TAKEN	
RECOMMENDATION	Install conduit as per the NEC
REMARKS	Two forms of conduit are mechanically connected for continuous ground path. NEC 300.10

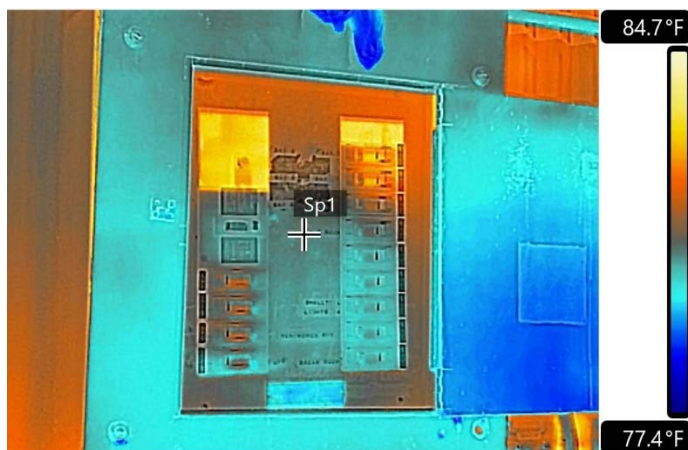
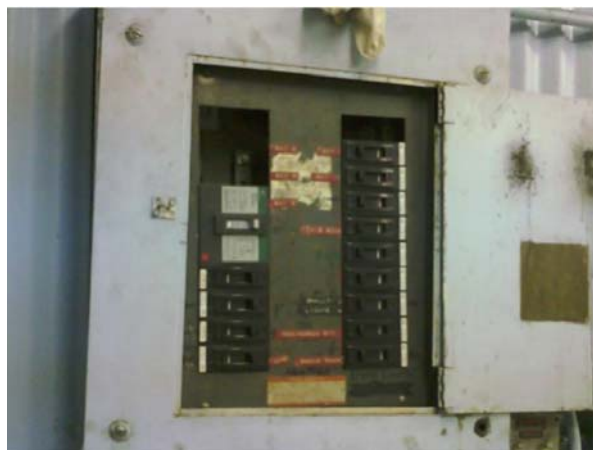
OWNER	NOMENCLATURE
	LOCATION: Men's Locker Room EQUIPMENT ID: Panel Shop Lighting TARGET: Openings in dead front CONDITION: Serious

PROBLEM	Unused breaker openings
CORRECTIVE ACTION TAKEN	
RECOMMENDATION	Install breaker filler plates
REMARKS	Panel cover door lock is damaged

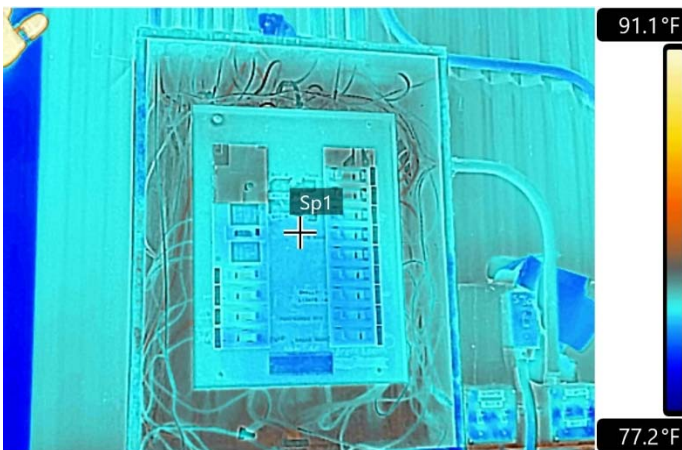
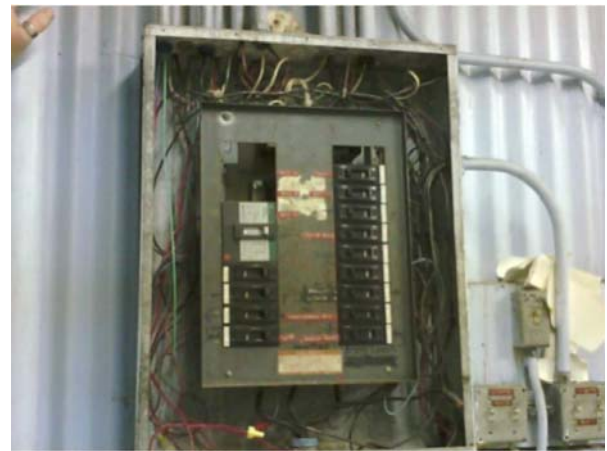
OWNER	NOMENCLATURE
	LOCATION: Men's Locker Room EQUIPMENT ID: Panel Shop Lighting TARGET: Breaker 7,9,11 CONDITION: Serious

PROBLEM	Wire attached to breaker is incorrect size
CORRECTIVE ACTION TAKEN	
RECOMMENDATION	Install #10awg wire from breaker to load
REMARKS	NEC violation

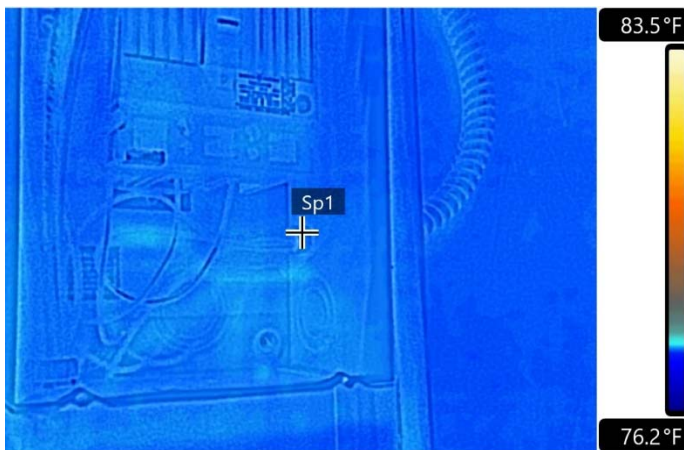
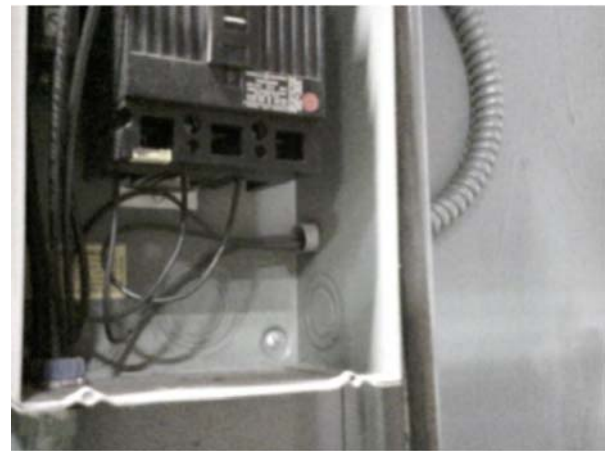
OWNER	NOMENCLATURE
	LOCATION: Drywall/East Wall EQUIPMENT ID: Breaker/Supply Fan TARGET: Flexible conduit connector CONDITION: Serious

PROBLEM	Missing locknut
CORRECTIVE ACTION TAKEN	
RECOMMENDATION	Install locknut
REMARKS

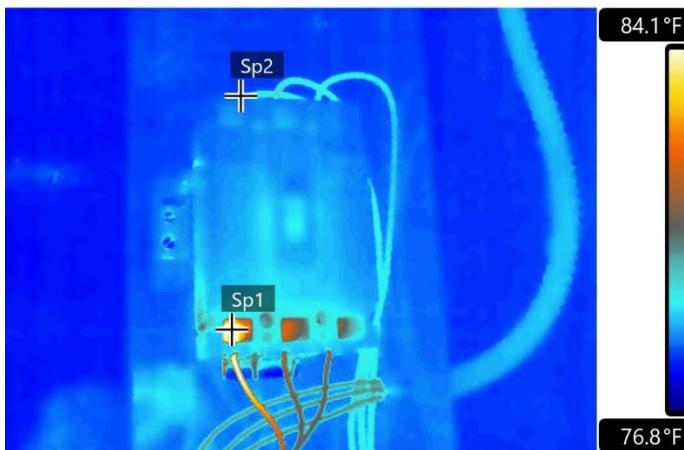
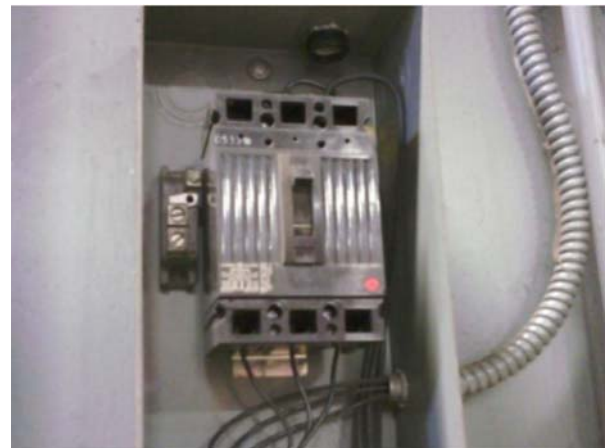
OWNER	NOMENCLATURE
	LOCATION: Drywall/East Wall EQUIPMENT ID: Breaker/#1 Fan TARGET: A-Phase load side wire connection CONDITION: Minor

Dt1 (Sp1 - Sp2)	7.0 °F
Sp1	85.4 °F
Sp2	78.4 °F
Areas	-
Ellipses	-

PROBLEM	Loose wire connection
CORRECTIVE ACTION TAKEN	
RECOMMENDATION	Screw was tightened
REMARKS	The flexible conduit connector at bottom right is missing the locknut

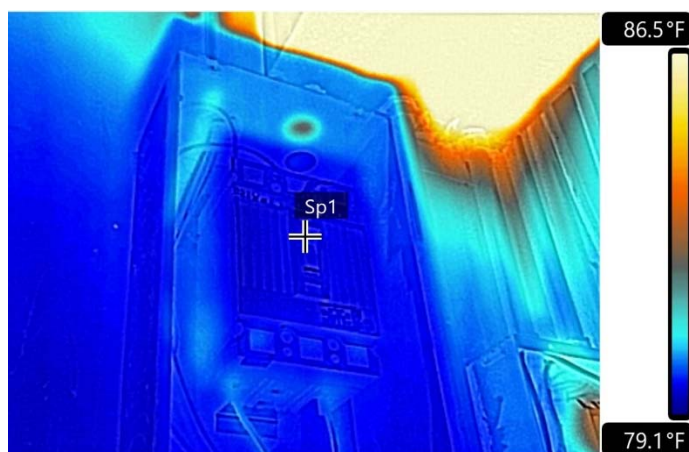
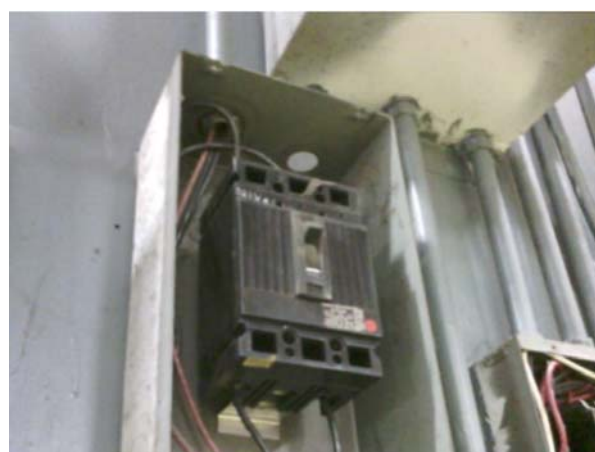
OWNER	NOMENCLATURE
	LOCATION: Drywall/West Wall EQUIPMENT ID: Breaker/N. Air Cond TARGET: Top of Enclosure CONDITION: Serious

TECHNICIANS SUMMARY	
PROBLEM	Unused openings
CORRECTIVE ACTION TAKEN	
RECOMMENDATION	Install knockout plug
REMARKS	Something laid on top of enclosure could fall inside and fault to ungrounded conductors.

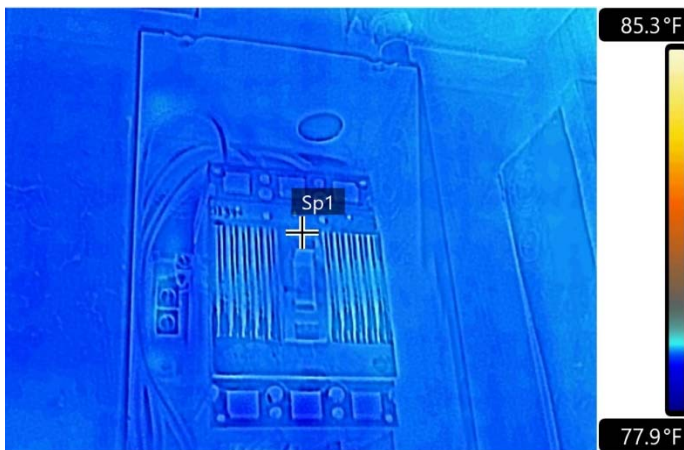
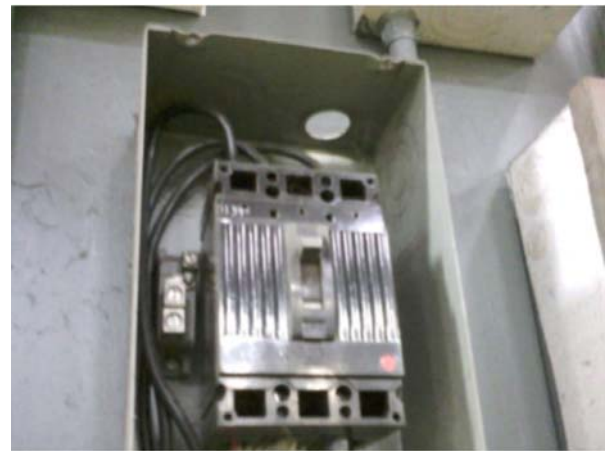
OWNER	NOMENCLATURE
	LOCATION: Drywall/East Wall EQUIPMENT ID: Breaker/#3 TARGET: Top of Enclosure CONDITION: Serious

PROBLEM	Unused openings
CORRECTIVE ACTION TAKEN	
RECOMMENDATION	Install knockout plug
REMARKS	Something laid on top of enclosure could fall inside and fault to ungrounded conductors.

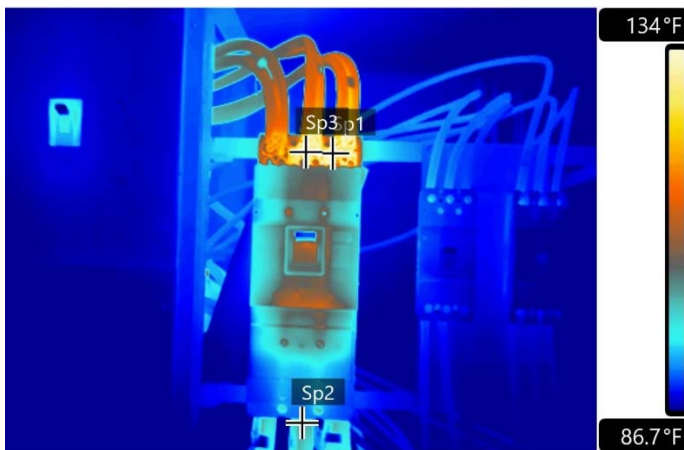
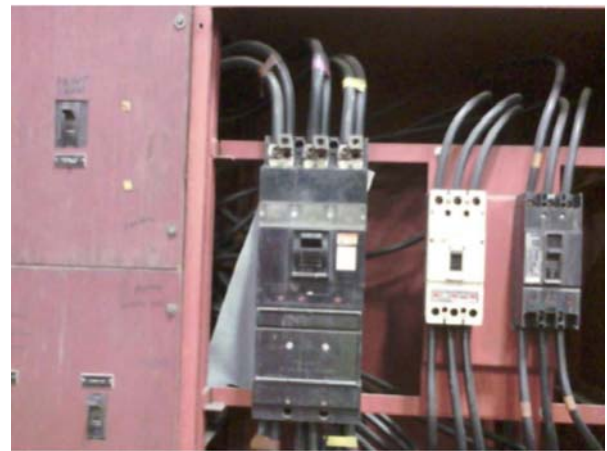
OWNER	NOMENCLATURE
	LOCATION: Drywall/South Wall EQUIPMENT ID: MDP/Sec 2/Main TARGET: Breaker/C-Phase line side wire connection CONDITION: Serious

Dt2 (Sp3 - Sp2)	28.6 °F
Dt1 (Sp1 - Sp2)	29.9 °F
Sp1	133.4 °F
Sp2	103.5 °F
Sp3	132.1 °F
Areas	-
Ellipses	-

PROBLEM	Loose wire connection
CORRECTIVE ACTION TAKEN	
RECOMMENDATION	Check all connections
REMARKS	Breaker is missing the wire cover similar to the one at bottom of breaker

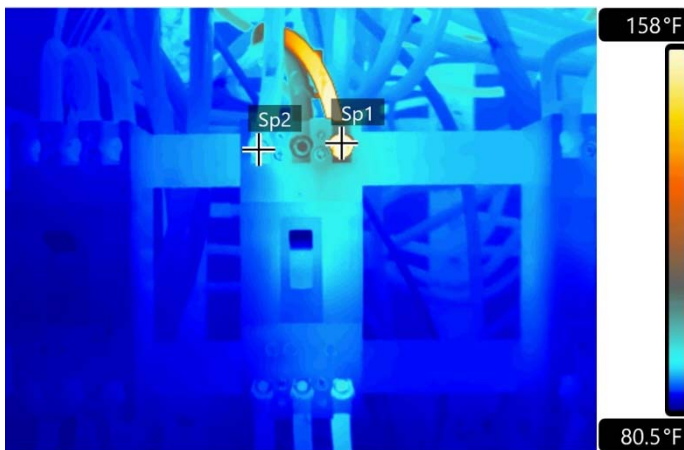
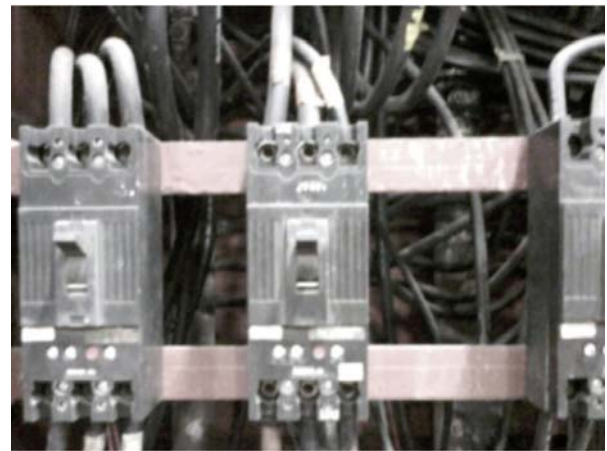
OWNER	NOMENCLATURE
	LOCATION: Drywall/South Wall EQUIPMENT ID: MDP/Sec 1/West Wall Feeder TARGET: Breaker/C-Phase line side wire connection CONDITION: Critical

Dt1 (Sp1 - Sp2)	92.8 °F
Sp1	188.2 °F
Sp2	95.4 °F
Areas	-
Ellipses	-

PROBLEM	Loose lug connection
CORRECTIVE ACTION TAKEN	
RECOMMENDATION	Check all connections
REMARKS	Remove hex set screw and wire to check lug to breaker connection.

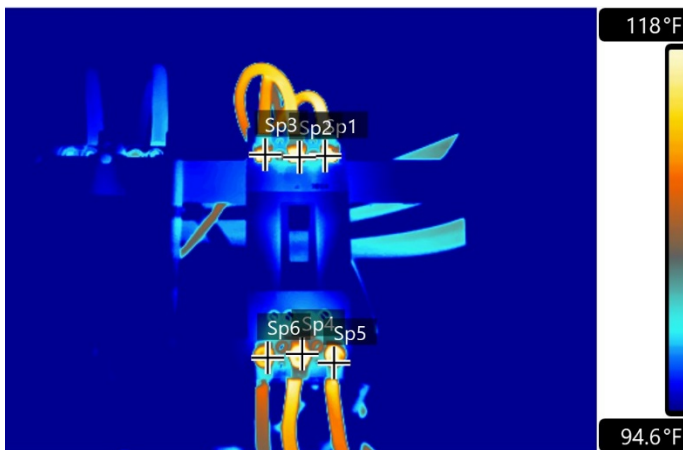
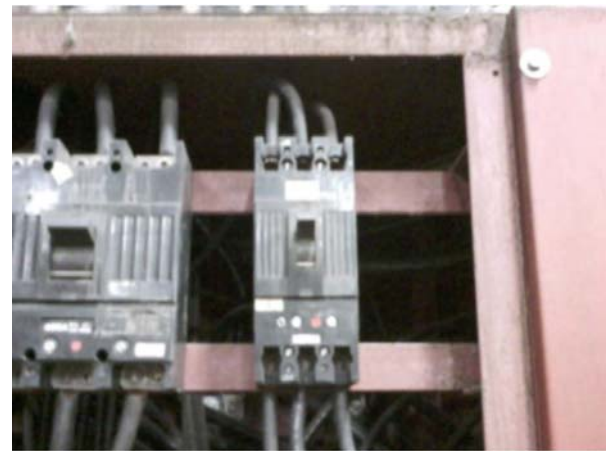
OWNER	NOMENCLATURE
	LOCATION: Drywall/South Wall EQUIPMENT ID: MDP/Sec 1/Paint Shop TARGET: Breaker/All connections CONDITION: Intermediate

Dt1 (Sp1 - Sp6)	13.0 °F
Sp1	127.5 °F
Sp2	127.2 °F
Sp3	119.0 °F
Sp4	121.3 °F
Sp5	118.9 °F
Sp6	114.5 °F
Areas	-
Ellipses	-

PROBLEM	Loose wire connection
CORRECTIVE ACTION TAKEN	
RECOMMENDATION	Check all connections
REMARKS	Remove hex set screw and wire to check lug to breaker connection.

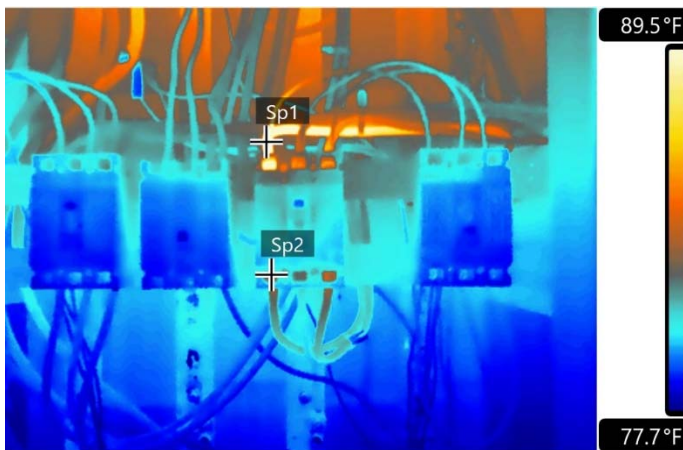
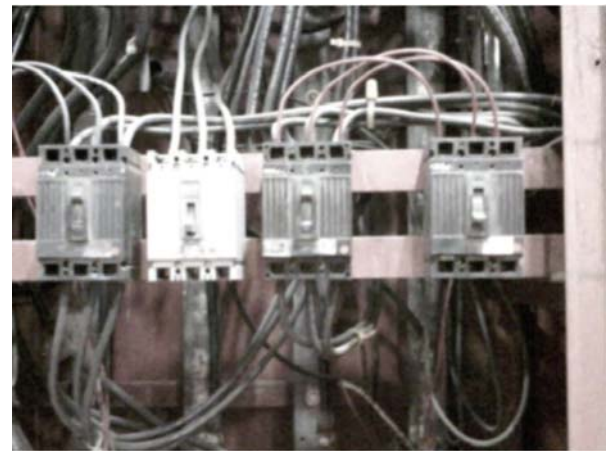
OWNER	NOMENCLATURE
	LOCATION: Drywall/South Wall EQUIPMENT ID: MDP/Sec 1/Shop Lighting TARGET: Breaker/A-Phase line side wire connection CONDITION: Intermediate

Dt1 (Sp1 - Sp2)	15.4 °F
Sp1	98.6 °F
Sp2	83.2 °F
Areas	-
Ellipses	-

PROBLEM	Loose wire connection
CORRECTIVE ACTION TAKEN	
RECOMMENDATION	Check all connections
REMARKS

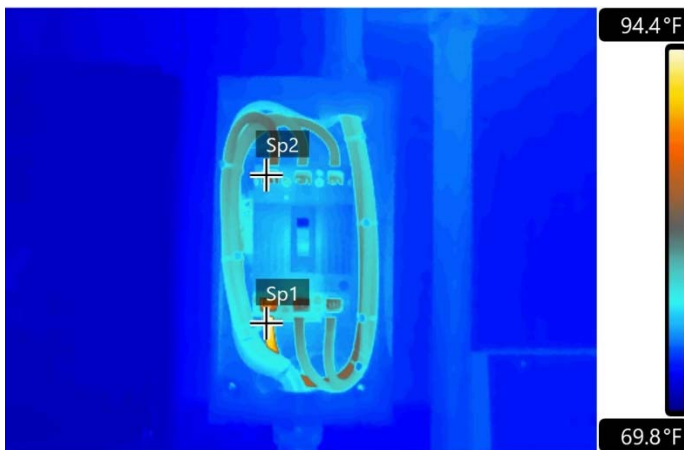
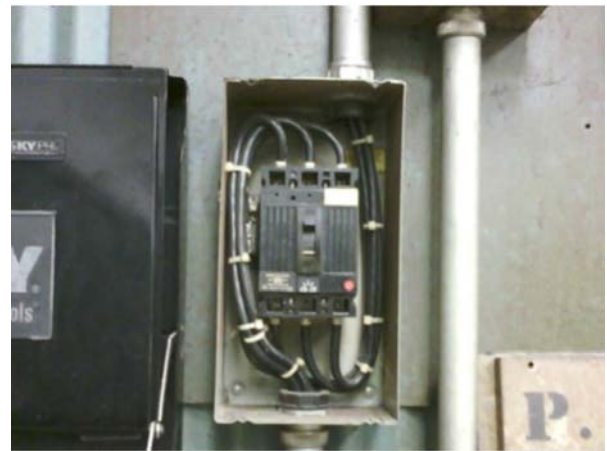
OWNER	NOMENCLATURE
	LOCATION: Tool Room EQUIPMENT ID: Breaker PD TARGET: C-Phase load side wire lug CONDITION: Intermediate

Dt1 (Sp1 - Sp2)	11.3 °F
Sp1	93.7 °F
Sp2	82.4 °F
Areas	-
Ellipses	-

PROBLEM	Loose lug connection
CORRECTIVE ACTION TAKEN	
RECOMMENDATION	Check all connections
REMARKS

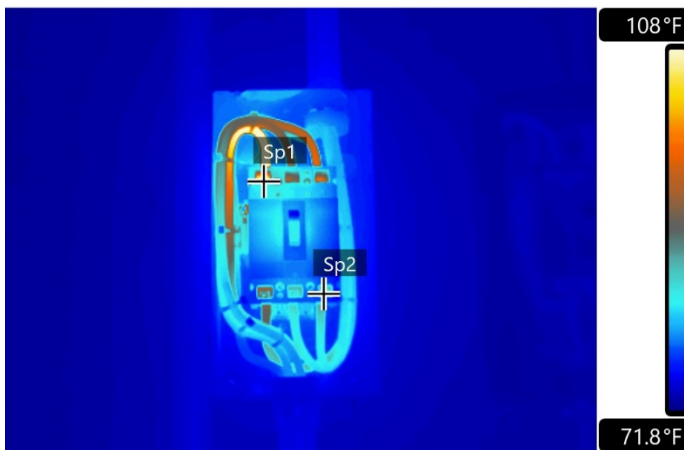
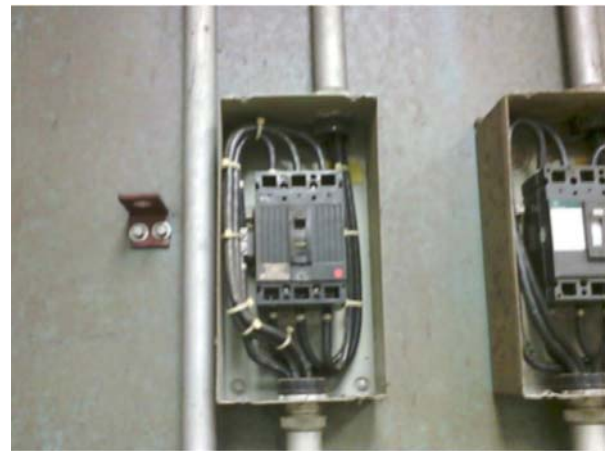
OWNER	NOMENCLATURE
	LOCATION: Tool Room EQUIPMENT ID: Breaker PC TARGET: All line side and C-Phase load side connections CONDITION: Critical

Dt1 (Sp1 - Sp2)	36.8 °F
Sp1	120.4 °F
Sp2	83.6 °F
Areas	-
Ellipses	-

PROBLEM	Loose wire connection
CORRECTIVE ACTION TAKEN	
RECOMMENDATION	Check all connections
REMARKS

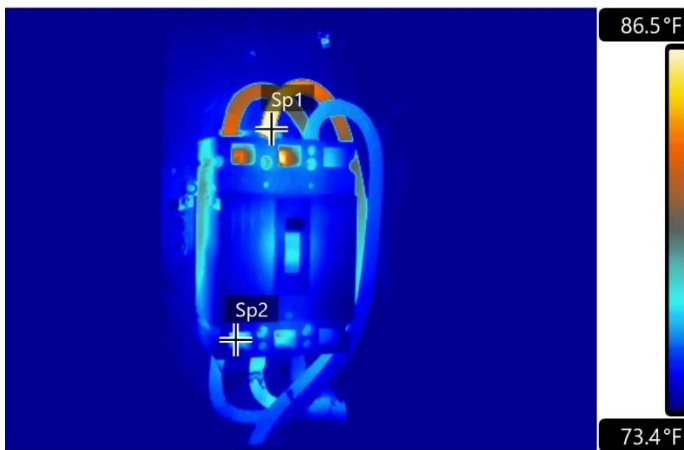
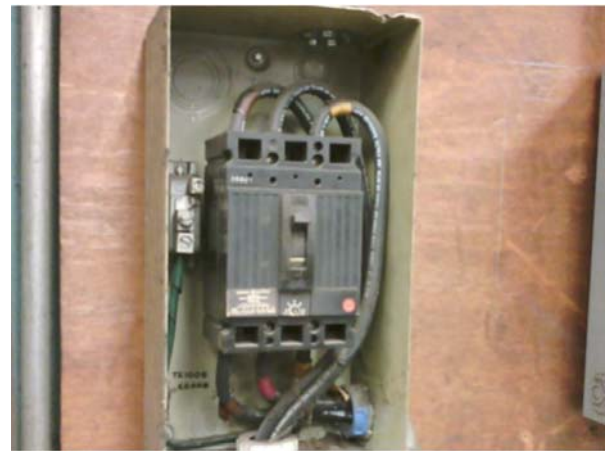
OWNER	NOMENCLATURE
	LOCATION: Tool Room EQUIPMENT ID: Breaker PB TARGET: B-Phase line side connection CONDITION: Minor

Dt1 (Sp1 - Sp2)	9.7 °F
Sp1	86.4 °F
Sp2	76.7 °F
Areas	-
Ellipses	-

PROBLEM	Loose lug connection
CORRECTIVE ACTION TAKEN	
RECOMMENDATION	Check all connections
REMARKS

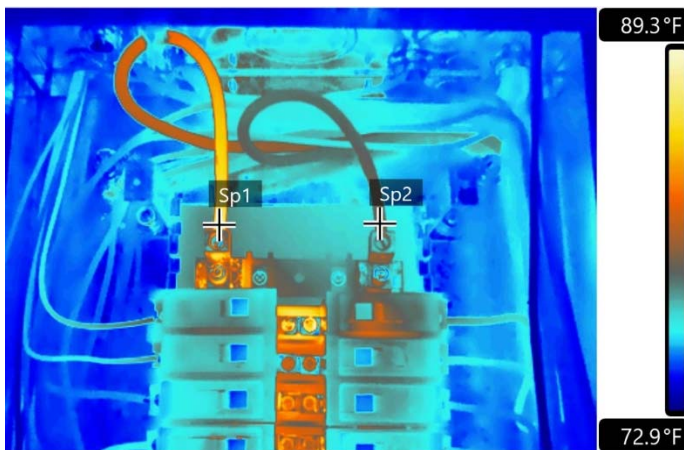
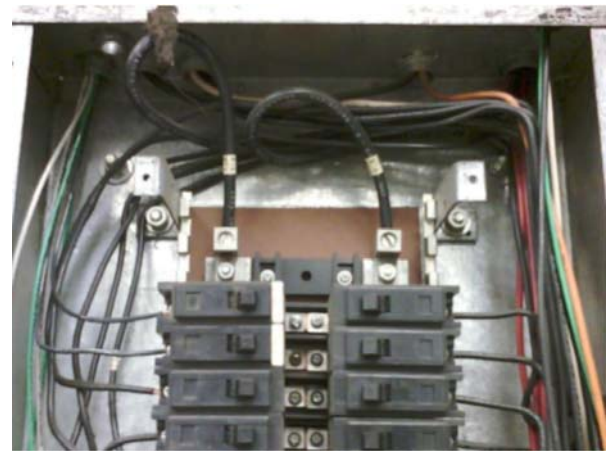
OWNER	NOMENCLATURE
	LOCATION: Tool Room EQUIPMENT ID: Panel BPTR-2 TARGET: A-Phase line connection CONDITION: Minor

Dt1 (Sp1 - Sp2)	8.2 °F
Sp1	88.3 °F
Sp2	80.0 °F
Areas	-
Ellipses	-

PROBLEM	Loose lug connection
CORRECTIVE ACTION TAKEN	
RECOMMENDATION	Check all connections
REMARKS	Single phase panel

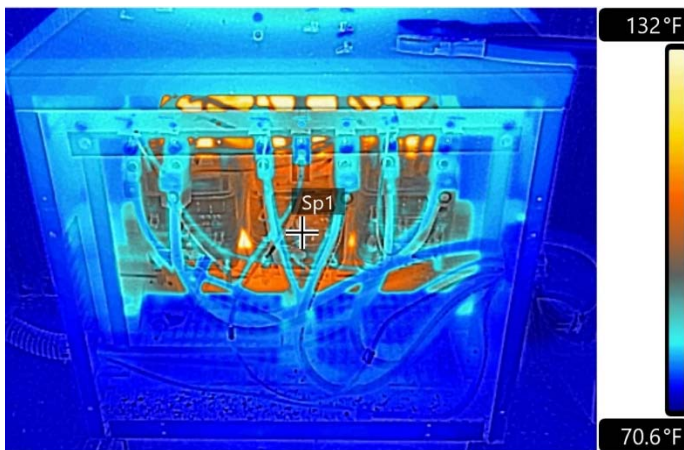
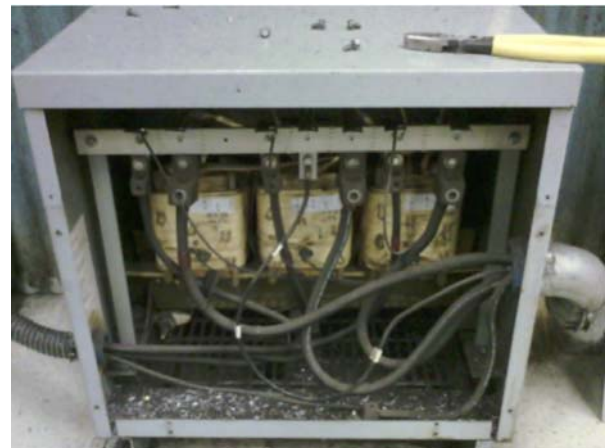
OWNER	NOMENCLATURE
	LOCATION: Tool Room EQUIPMENT ID: T-TRBP-1 TARGET: Neutral lug CONDITION: Critical

PROBLEM	Improper connection and wire sizing
CORRECTIVE ACTION TAKEN	
RECOMMENDATION	Install correct size neutral and grounding conductors
REMARKS	Transformer is not properly grounded to the XO lug and building steel as per the NEC. Neutral is improperly sized. Missing protective bushings on both entry conduits.

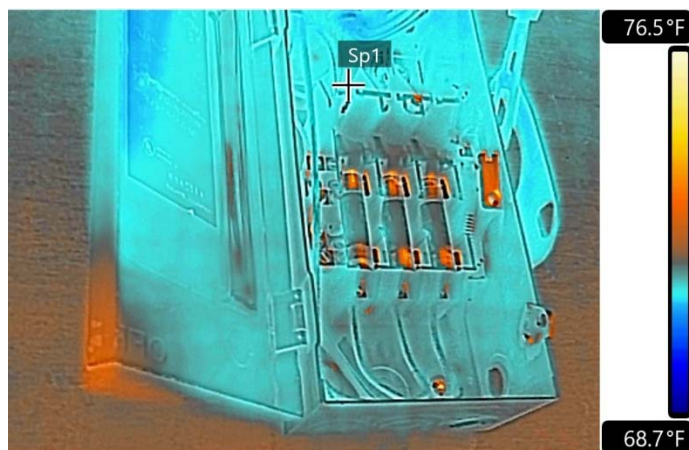
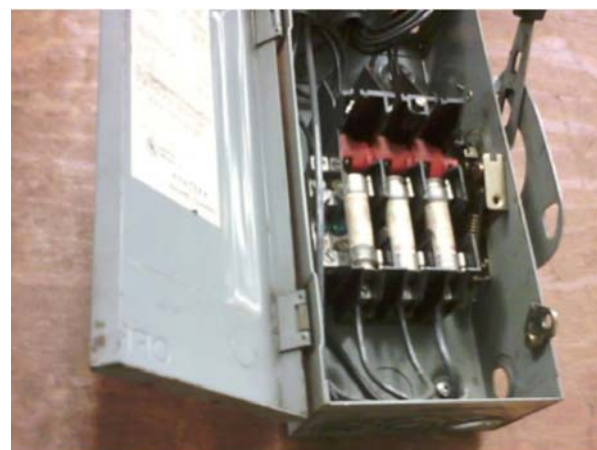
OWNER	NOMENCLATURE
	LOCATION: Tool Room EQUIPMENT ID: Disconnect/Victor Lathe TARGET: Unused openings CONDITION: Serious

TECHNICIANS SUMMARY	
PROBLEM	Unused openings
CORRECTIVE ACTION TAKEN	
RECOMMENDATION	Install knockout plug
REMARKS
